Circo Club rooftop pool

Location	Dallas, TX
Architect	Humphreys & Partners
Client	Rareform
Year	2016

Job Data Sheet

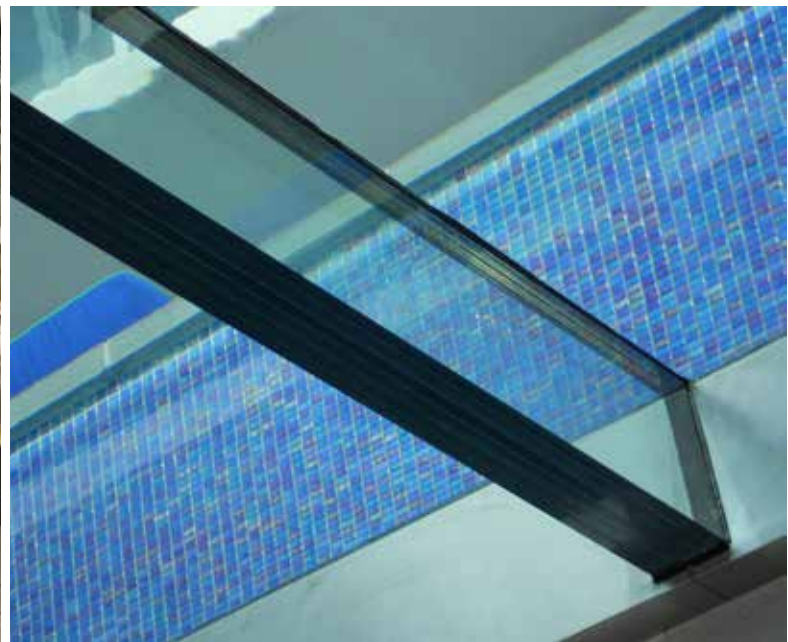
Glass Make-ups

FINS

3/4" Low Iron Tempered	0.060"
SGP	
3/4" Low Iron Tempered	0.060"
SGP	
3/4" Low Iron Tempered	0.060"
SGP	
3/4" Low Iron Tempered	0.060"
SGP	
3/4" Low Iron Tempered	0.060"
SGP	
3/4" Low Iron Tempered	0.060"
SGP	
3/4" Low Iron Tempered

POOL BOTTOM

3/4" Low Iron Tempered	0.060"
SGP	
3/4" Low Iron Tempered	0.060"
SGP	
3/4" Low Iron Tempered	0.060"
SGP	
3/4" Low Iron Tempered	0.060"
SGP	
3/4" Low Iron Tempered
